Comparison of the Interfacial Bond Strength Behaviour using Shear Key

¹Karan Shah ²Rohit Tripathi ³Deval Master ⁴Abhay Kumar Yadav

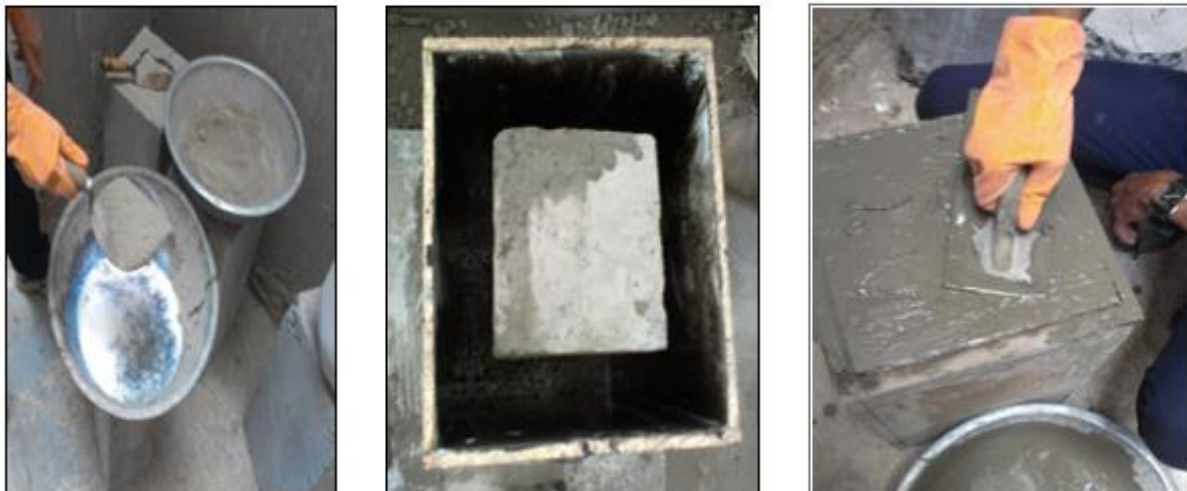
Fig. 3: Application of SBR on specimen_SK and Finishing

For the bond between two layers three specimens were casted without using anything and another three were casted using SBR chemical and shear key. SBR was applied by brush on chipped surface as usual procedure.

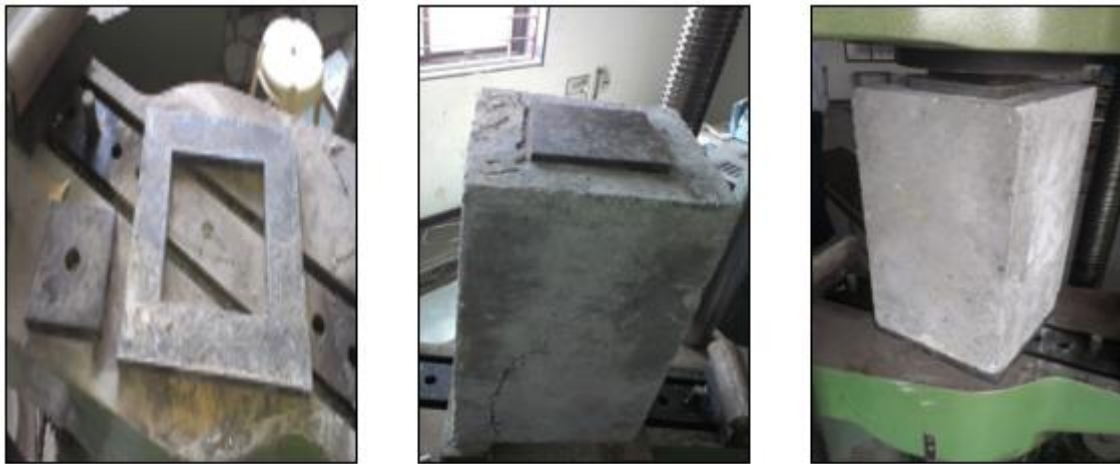
Fig. 4: Test setup

Hollow Mild Steel (MS) plate was first of all placed on Universal Testing Machine (UTM) base. Then, jacketed specimen was placed on hollow MS plate in such a way that it supported jacketed layer. On the top of specimen, 140 x 140 mm solid plate was placed in such a way that it rested on parent column and thus loading process was undertaken and load was applied.

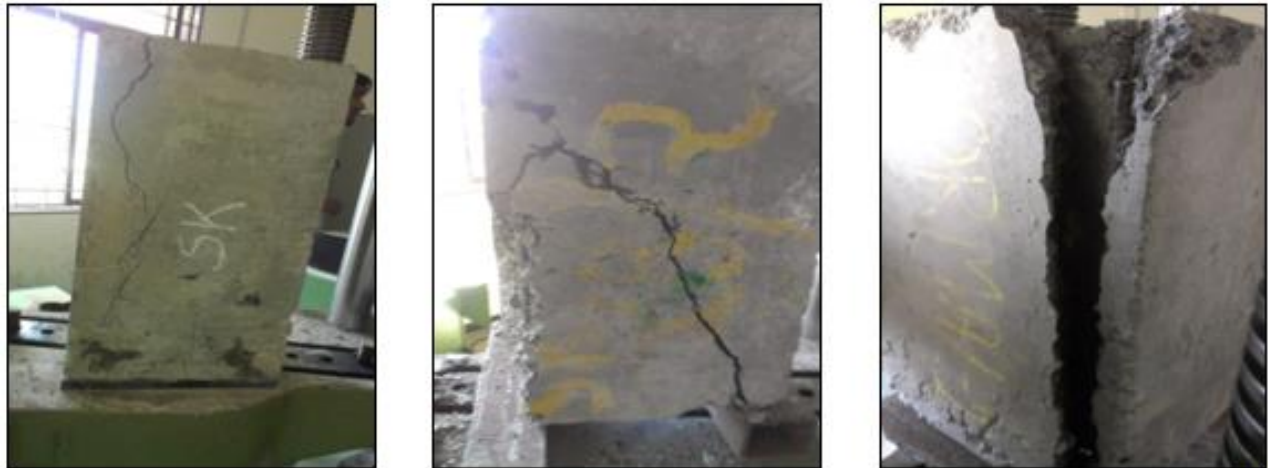
Fig. 5: Failure of specimen_SK

Based on experimental results, efforts have been made to study the bond slip phenomenon and to compare the effectiveness of jacketing techniques used in this study. Following are some of the observations of bond slip under application of load through Universal Testing Machine.

In case of specimen with shear key and SBR, we observe that the bond slip did not occur but the different phenomenon took place. Previously when the shear key was not provided, there were no restrictions for the occurrence of bond slip and that's why the parent column suffered from minor damage but in case of specimen with shear key, bond slip was resisted by shear key as well as SBR. Load coming over the parent specimen was transferred to collar through shear key mechanism because of which occurrence of bond slip was resisted and expansive failure of parent specimen was observed resulting in the tearing effect of jacketed layer. This type of expansive failures may be avoided by providing higher grade concrete in the jacketed portion which will resist the quantum of force coming from parent specimen and this can be the future area of work which one can opt for.
